Maintaining Full Production in Furnaces with Failing Regenerators Using Oxy-fuel Combustion

William J. Horan

Air Products and Chemicals, Inc.

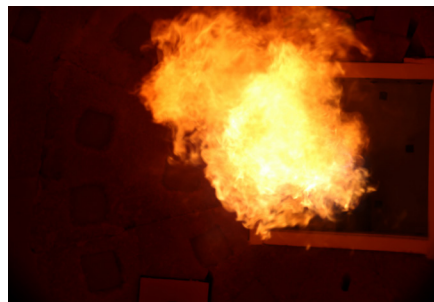
0 degree tilt, full staging

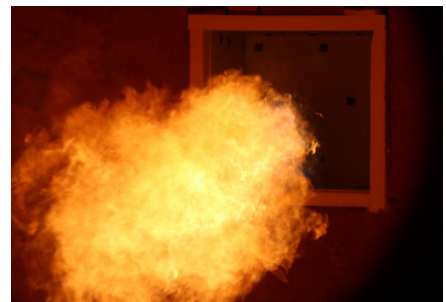
5 degree tilt, full staging

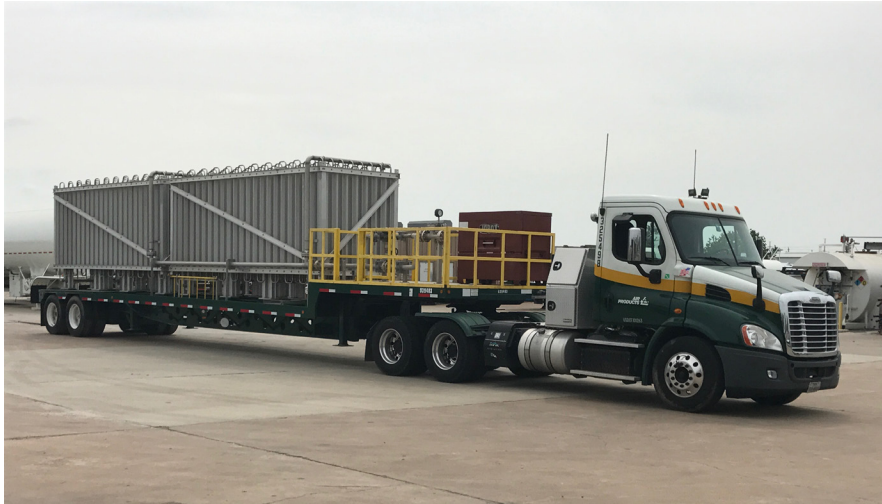
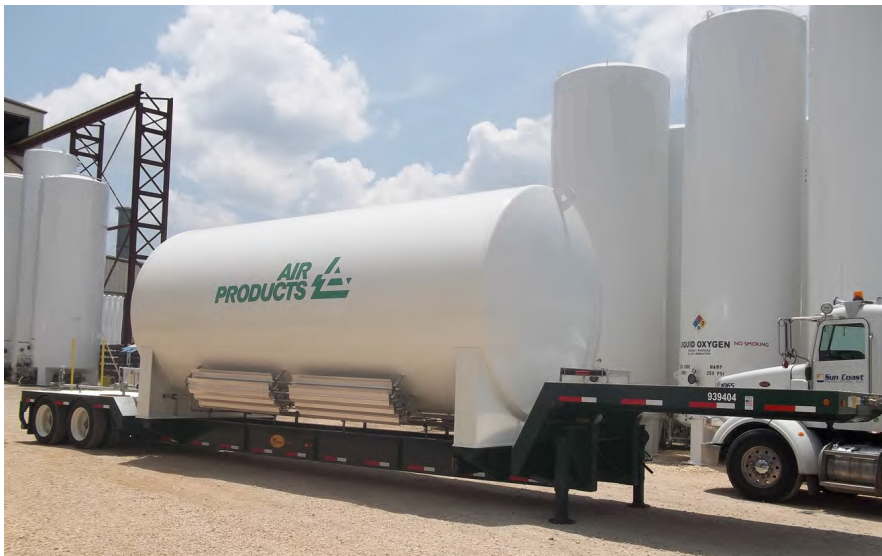
Figure 5: Typical APEX Units

It was determined that due to the volume of oxygen required, APEX Express Service units would be used to provide additional on-site oxygen storage and vaporizing capacity. These units consisted of four portable trailers, two for LOX storage and two with dual vaporizer banks. Figure 5 below is a picture of the APEX units.

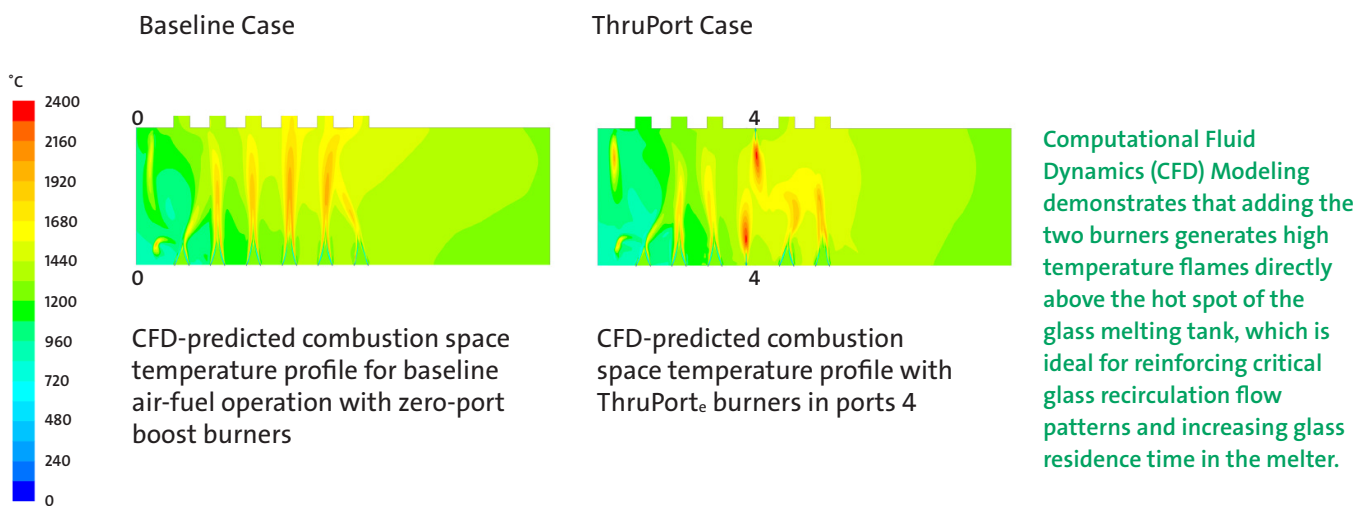
Figure 6: CFD Combustion Space Temperature Profiles

To verify the fuel and energy savings seen at Plant #1, a CFD modeling study was conducted. The results of that model are summarized in Table 1. The baseline case was conducted at full pull rate prior to oxygen lancing, with regenerators operating as expected and two of the four boost burners. The fouled regenerator case was at a reduced pull rate, no lancing and four boost burners. The last case is the furnace operating at full pull rate, two ThruPort burners, lancing on three ports and two boost burners. The energy savings produced with the installation of two ThruPort burners and three ports of oxygen lancing show a 9.8% reduction, similar to what was seen in the field and similar to the fuel savings observed at other installations. Figure 6 shows the combustion space temperature profile predicted by the CFD model, with zero port boost burners and normal air fuel firing on all six ports on the left. On the right is the temperature profile predicted with ThruPort burners in the #4 port and zero port boost burners.

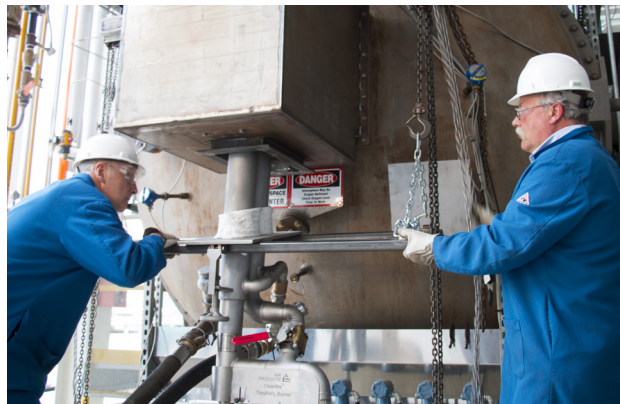
Figure 7: ThruPort Mock Installation

Preparations prior to the installation of the ThruPort burners included port modifications, such as cutting a hole in the port bottom grating and saw cutting a similar hole in the port bottom refractory. The cooling water supply and return lines, and the oxygen and natural gas tie-in points were identified, and appropriate flex hoses and fittings obtained. The logistics of the lift mechanism and how it would be positioned between and under the port was determined. Finally, training was conducted with regard to oxygen safety, as well as installation and operation of the ThruPort burner. Figure 7 is a picture of a mock installation conducted in one of Air Products' combustion laboratory furnaces. Figure 8 is a picture showing the burner installed in the #4 port prior to the back of the port being blocked off.
